An overview on the solid byproducts of the galvanizing kettle

G. VOURLIAS, N. PISTOFIDIS, G. STERGIODIS, E. K. POLYCHRONIADIS*

In galvanizing process several byproducts are formed. Among them solid materials composed of different compounds are grown in the galvanizing kettle. The present work examines the structure of the galvanizing ashes, bottom dross and blowing waste with Scanning Electron Microscopy (SEM), Transmission Electron Microscopy (TEM) and X-Ray Diffraction (XRD). From this research it was deduced that these byproducts are mainly composed of different zinc compounds, while a large amount of iron in the form of oxides or Fe-Zn intermetallics is also present. In any case, the examined materials are suitable for zinc recovery, although their composition and the structure is highly different in every case.

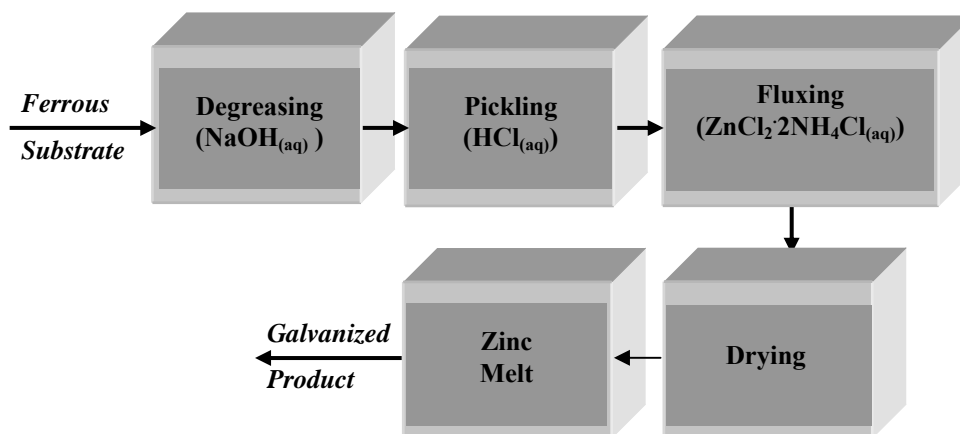
Fig. 1. Schematic diagram of a typical batch hot-dip galvanizing line. The chemical substances used in every step are presented in the brackets. The index (aq) implies aqueous solution.

A rough flow sheet of a typical hot-dip galvanizing line is presented in Fig. 1. Both floating and the bottom dross samples were provided batch hot-dip galvanizing facilities. These samples were collected right after being removed from the zinc kettle, while the blowing waste was provided by a tube mill. The samples of the clean zinc bath and the pure zinc ingots were provided by the same industries. The zinc bath was considered "clean" right after the usual removal of the bottom and floating dross, as it is performed in the industry (mechanically with the usage of suitable shovels). The samples of the clean bath were collected with a special device from three different depths (10, 100 and 150 cm below the zinc surface).

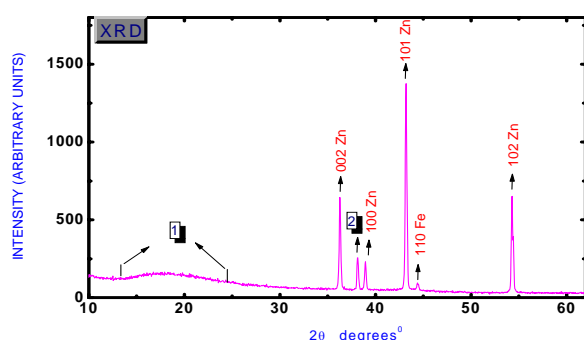
Fig. 2. XRD pattern of the pure zinc bath (1: amorphous Zn and Fe phases, 2: $ZnCl_2$).

The examination with XRD is in accordance with the EDS results. As a matter of fact, it verifies the presence of zinc, iron and amorphous zinc and iron chlorides (Fig. 2). TEM also detected pure Zn (PDF#040831 [14]), as it was expected. However, the diffraction patterns of Fig. 3a and 3b prove that, apart from pure Zn, Fe-Zn solid solutions and Fe-Zn phases (PDF#320478 and PDF#341314[14]) are present in the examined sample.

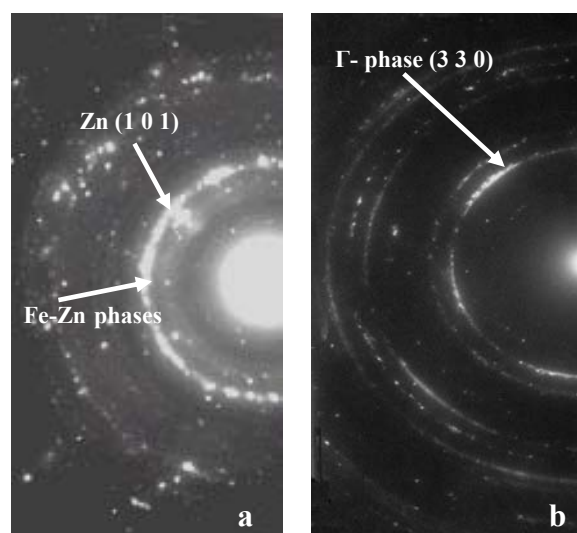
Fig. 3. Diffraction pattern of the zinc bath (a: Zn and Fe-Zn solid solutions, b: Γ -phase).

The presence of Fe-Zn solid solutions is indicated by the small shift of the zinc diffraction rings relatively to the position of the rings of pure Zn. These compounds are most probably formed during the solidification of the liquid sample, which was taken from the kettle, since the Zn bath contains a small concentration of dissolved Fe. They are not visible with XRD due to their low concentration.

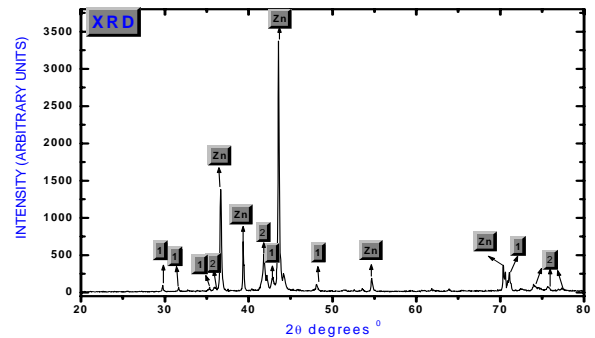
Fig. 11. XRD pattern of the bottom dross. Peaks noted with #1 and #2 refer to the ζ -phase of the Fe-Zn phase diagram.

of these phases is presented. This table shows that the darker area between the lighter fragments (phase #1 in Fig. 10b) is composed almost exclusively by Zn. This is probably the liquid Zn trapped in the device used for the cleaning of the kettle. The white spots (phase #3 in Fig. 10b) observed in this phase contain a large amount of Pb. Pb is added in the molten Zn in order to diminish the surface tension of the liquid and consequently reduce the coating thickness [13]. However the Pb solubility in liquid Zn is low, therefore a layer of molten Pb precipitates at the bottom of the Zn kettle. It is likely that this layer is the source of Pb in the examined specimen. The lighter areas of the dross (phase #2 in Fig. 10b) are mainly composed by Zn, while they contain also about 6 wt.% Fe. This composition is typical for the ζ (zeta) phase of the Fe-Zn phase diagram [1]. This phase is insoluble in molten Zn and its melting point (about 530°C [1]) is higher than the kettle temperature (about 450°C). Consequently, particles of this phase, formed when the Fe concentration in the kettle is above its solubility, precipitate at the bottom of the liquid Zn. This could be considered as the main byproduct, while Zn and Pb are removed because of the imperfect method used for the cleaning process. The presence of Zn and the ζ -phase was also identified with XRD (Fig. 11).
